DEPARTMENT OF TRANSPORTATION**DIVISION OF ENGINEERING SERVICES**

Contract #: 04-0120F4Cty: SF/ALA Rte: 80 PM: 13.2/13.9File #: 1.28**WELDING INSPECTION REPORT****Resident Engineer:** Siegenthaler, Peter**Address:** 333 Burma Road**City:** Oakland, CA 94607**Report No:** WIR-018163**Date Inspected:** 15-Nov-2010**Project Name:** SAS Superstructure**OSM Arrival Time:** 1000**Prime Contractor:** American Bridge/Fluor Enterprises, a JV**OSM Departure Time:** 1830**Contractor:** American Bridge/Fluor Enterprises, a JV**Location:** Jobsite**CWI Name:** See below**CWI Present:** Yes No**Inspected CWI report:** Yes No N/A**Rod Oven in Use:** Yes No N/A**Electrode to specification:** Yes No N/A**Weld Procedures Followed:** Yes No N/A**Qualified Welders:** Yes No N/A**Verified Joint Fit-up:** Yes No N/A**Approved Drawings:** Yes No N/A**Approved WPS:** Yes No N/A**Delayed / Cancelled:** Yes No N/A**Bridge No:** 34-0006**Component:** SAS OBG**Summary of Items Observed:**

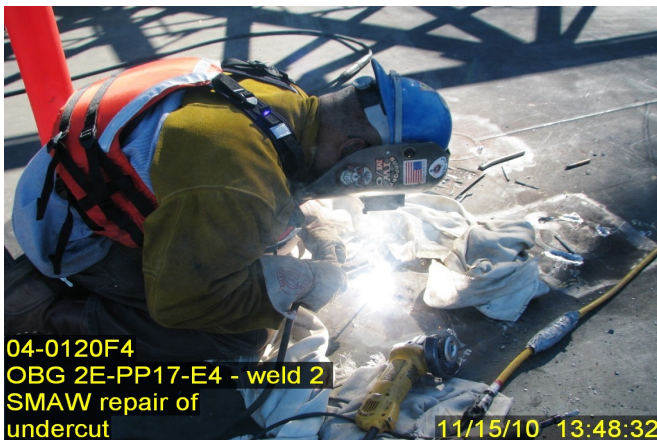
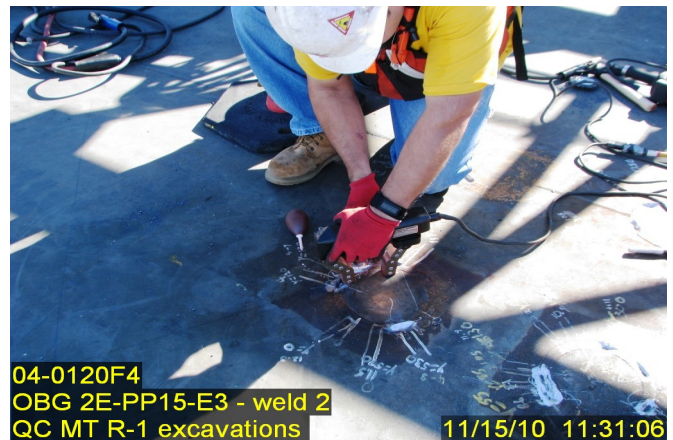
The QAI periodically observed AB/F approved welder Earl Espinoza (ID 5824) performing welding per the Shielded Metal Arc Welding (SMAW) process in the 1G (flat) position of E4-welds 2 and 3. See photo below. The welding at this location was to repair undercut based on QC VT. QC Inspector Patrick Swain was periodically present to monitor the progress and verify that the welding parameters were within the limits established by the approved welding Procedure Specification (WPS) identified as ABF-WPS-D1.5-1070. The QAI observed that the work was completed at this location and appeared to be in general compliance with contract documents.

The QAI performed verification Visual Testing (VT) of 10% of the lengths of OBG Field Splice 7W/8W Weld ID: A3-A5 and Ultrasonic Testing (UT) of 10% of the lengths of OBG Field Splice 7W/8W Weld ID: A1-A5. The OBG Field Splice 7W/8W Weld ID: A2, A3 & A5 verified by the QAI appeared to be in general compliance with contract documents. The OBG Field Splice 7W/8W Weld ID: A1 & A4 verified by the QAI did not appear to be in general compliance with contract documents. On weld A4 at Y = 5465mm the QAI observed an Arc Strike and on weld A1 at Y = 2835mm the QAI observed a base metal gouge and a temporary attachment remnant (scab) at approximately Y = 2350mm. The QAI also observed (1) UT rejectable indication (Class A Reject) at Y = 2480mm. See Ultrasonic Testing Report Form TL-6027 generated by the QAI on this date. The QAI informed QC Lead Inspector Bonafacio Daquinag of the results of the QAI verification testing at this location. See Summary of Conversations Below.

The QAI approached Mr. Daquinag and informed him of the visual and ultrasonic indications observed by the QAI. Mr. Daquinag stated that he would see to it that the UT indication was verified / confirmed and that the visually observed indications would be rectified
